TECHNICAL REPORT NATICK/TR-01/016

# COMPARISON OF THE CENTRALIZED HEATING UNIT COGENERATION KITCHEN (CHUCK WAGON) PROTOTYPE WITH THE MOBILE KITCHEN TRAILER (MKT) AND MOBILE KITCHEN TRAILER-IMPROVED (MKT-I)

September 2001

Final Report December 1999 - January 2000

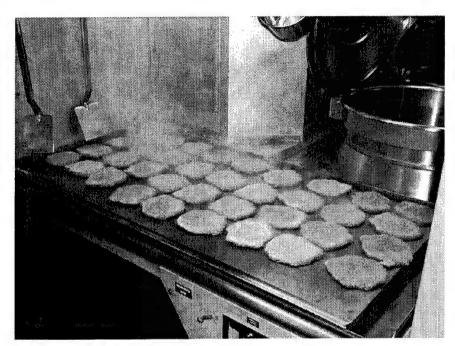
Figure 11. CHUCK Wagon Griddle

The CHUCK griddle with a full load of burgers is shown in **Figure 11.** A grease trough ½" wide and ¼" deep runs along the front edge. Ideally it prevents overflow and helps direct grease into the 3" wide, 3" deep trough running along the right side of the griddle from front to back. The trough along the front edge was too shallow to prevent overflow or effectively funnel the grease. It is recommended that this trough be made deeper, or a sidewall be put up, and a similar trough be included along the back of the griddle.

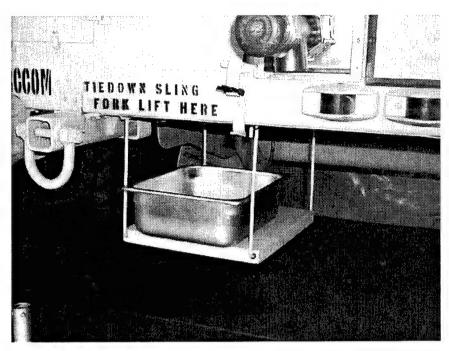
Figure 12. Shelf for Grease Collection Tray

At the rear of the 3" trough is a 2" drain hole penetrating to the trailer bottom. At the time of testing there was no special provision installed to catch grease draining out this hole, so an empty #10 can was used and found to be adequate for the 250 hamburgers cooked. A suitable grease collection device was installed soon after testing (**Figure 12**). It consists of a tray that during transport clips to the trailer bottom. Without looking and with one hand, a soldier can free the tray and allow it to swing down on hinges. The tray will support #10 cans, Cambro inserts (as in the figure), and empty traypacks, so disposable containers of sufficient capacity are readily available at all times. The cooks must be trained to ensure a container is always in place prior to using the griddle; this will prevent hazards associated with allowing grease to spill on the ground.

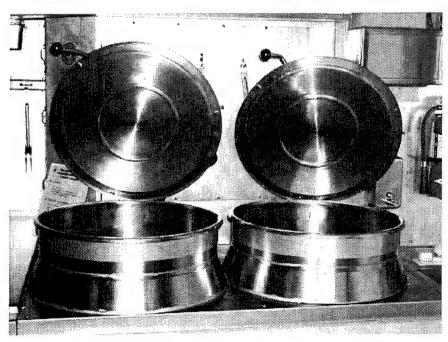
Figure 16. CHUCK Wagon 20 Gallon Kettles

During the exercise cooks tried to empty the kettle of corn through the drain spigot and it quickly clogged. With this type of spigot, even if the contents had a sufficiently low particulate size and viscosity to flow, the valve tends to splatter and could burn cooks. Although the drain configuration is NSF approved, it was difficult to clean. The straight through ball valves on the Rapid Deployment Kitchen allowed a variety of dishes to pass through, they were easy to unclog and easy to clean. It is recommended the kettles be drained only when there are no large food particles, with the spigots removed, or during cleaning.

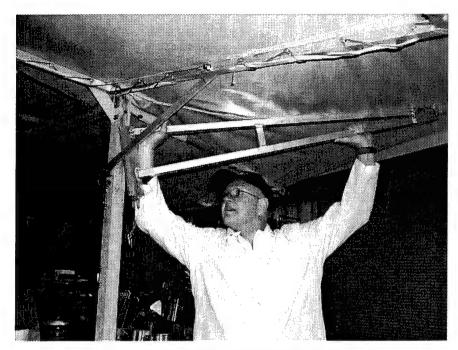
Figure C-6 Installing Corner Support

Putting corner supports on canopy - needed a hammer to do this (the holes were somewhat tight). Installing corner supports requires 2 people -1 to hold the canopy up and the other to install the pins

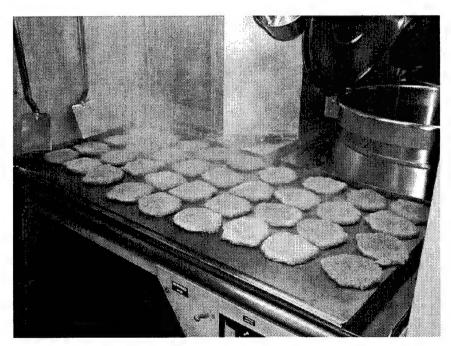
Figure C-18 Griddle with Full Capacity of Burgers

The griddle surface is 44"W x 21"D. There is a grease trap at the right end, which is 3"W x 22"D and sinks down 3" in depth. At the back corner of the grease trap is a hole, where the grease will drain through. There is nothing below the hole to catch the grease. The grease will drip right onto the ground. For this demo, an empty #10 can was placed below the grease hole to catch the grease. The griddle with a full load of burgers is shown in **Figure C-18.**

Scraped down grease on griddle – scraped from front to back and left to right. The grease splashes over the back guard behind the griddle, and into the area behind the left kettle. In addition to increasing the cleaning burden, there is also the possibility of a grease fire, though remote due to zero ignition sources. Recommend a higher backsplash be provided.

The griddle has a channel for grease to flow to the trap along the front edge. Recommend a channel along the back edge as well. The flow of grease is being restricted by the food being cooked on the griddle.
